BICYCLE, PEDESTRIAN & TRAILS COMMITTEE MEETING AGENDA

SUBJECT: ANNUAL BICYCLE AND PEDESTRIAN COLLISION DATA

Annual Collision Analysis 2025

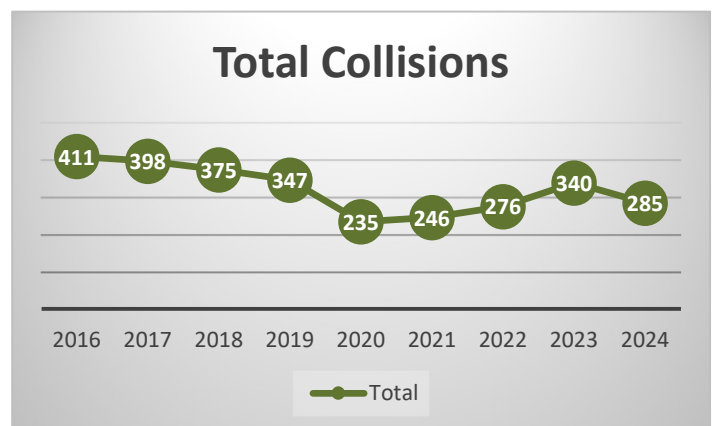
The total number of collisions for the current year was approximately 16% less than the prior year's number of collisions (285 compared to 340) and almost equal to the previous three-year average of 287.

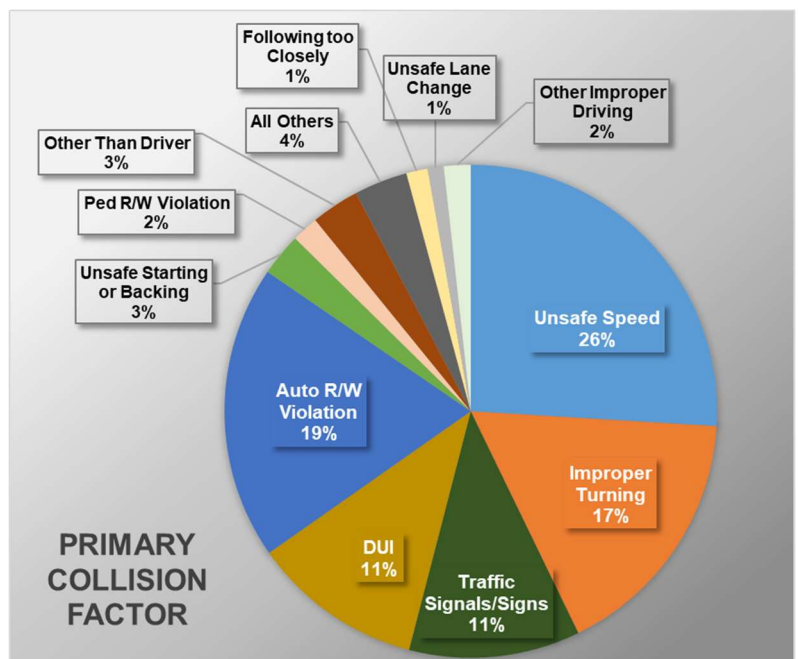
Primary collision factors³ (by percentage) showed a five percent increase in both unsafe speed and auto right-of-way collisions compared to previous years. There was a decrease of five percent in improper turning collisions.

Unsafe speed and auto right-of-way are the most common reasons for collisions. The two combine to account for 45% of all collisions. Historically, improper turning is the second most common collision factor. However, this year it has fallen to number three.

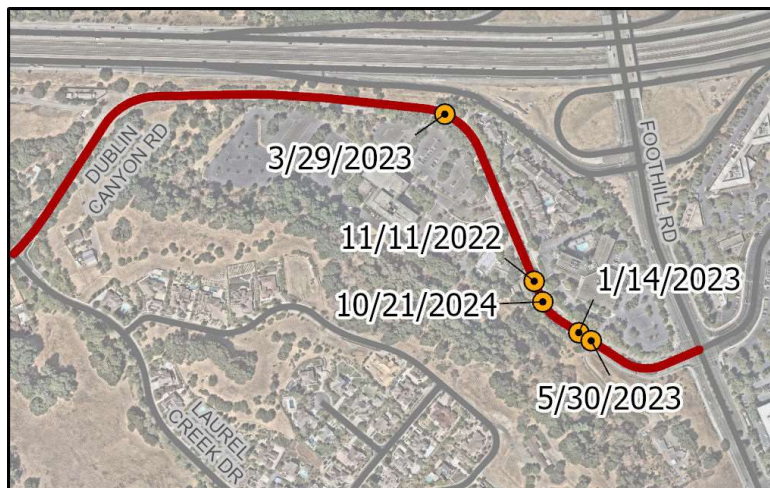
Dublin Canyon Road from Foothill Road to Laurel Creek Drive

All five collisions were hit object (all different objects) and in three of those collisions the driver was DUI or lost consciousness.

In past reports there was a pattern of collisions at the westernmost curve. Additional and larger signs were installed on this curve in 2016. No collisions appear at that location on this report.

Pavement striping was evaluated last year and found to be adequate. This roadway was resurfaced in September 2024. We added some additional striping through the western most curve to add extra notification of curves in roadway. Caltrans countermeasure R28.

Inform Police Department of prevalence of DUI collisions on this section of roadway.

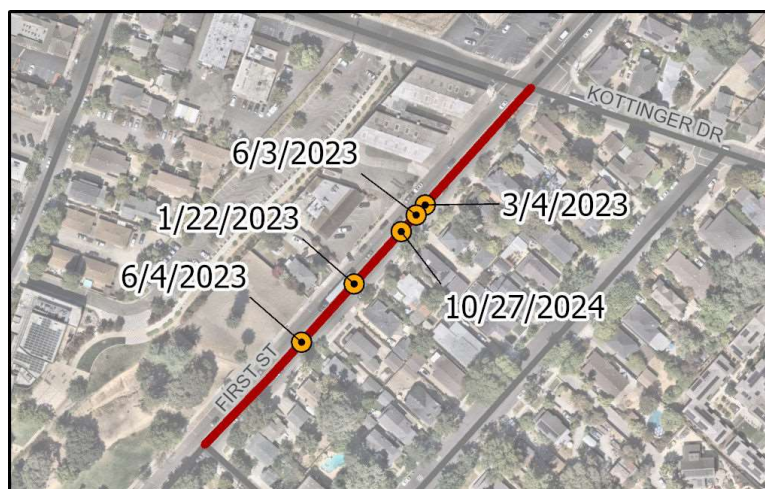
First Street from Arendt Way to Kottinger Drive

All five collisions were northbound rear-end collisions, with four of them rear-ending a parked northbound vehicle. In three of the collisions the driver fell asleep or was driving under the influence. In the remaining two collisions the driver fled the scene before police arrived (sobriety/consciousness at time of collision undetermined). Four of the collisions occurred in the early morning hours in the dark, and all five occurred on the weekend.

Inform Police Department of prevalence of DUI collisions on this section of roadway.

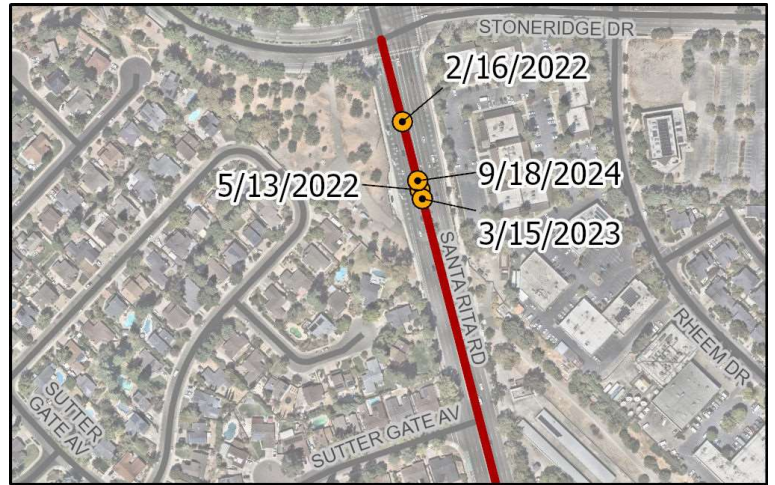
Santa Rita Road from Sutter Gate Avenue to Stoneridge Drive

Three of the four collisions were analyzed on last year's report. One new collision occurred this year. Two of the four collisions were northbound rear-end collisions into stopped vehicles at the red light at Stoneridge Drive. Both of these collisions happened midday on a weekday.

We recommended an evaluation of midday traffic signal timing to see if more green time can be given to this direction. Caltrans countermeasures S03. Staff is finalizing signal timing through this corridor.

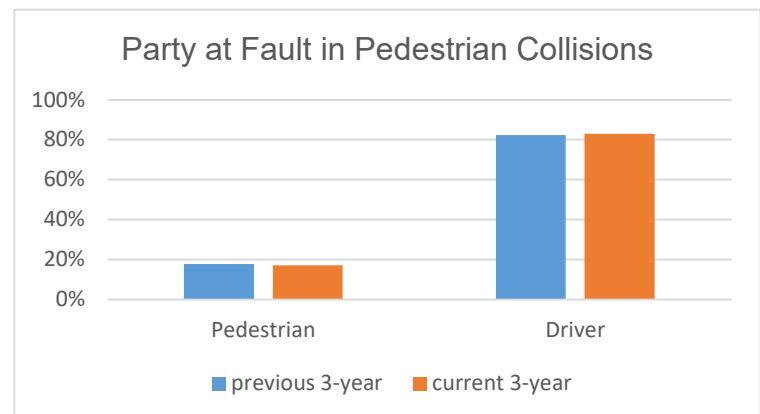
The chart to the right illustrates the percentage of collisions that occurred in marked and unmarked crosswalks, in the roadway (outside of a marked or unmarked crosswalk), or at a driveway. While the number of collisions at marked crosswalks is greater than the other location types, this does not necessarily equate to reduced relative safety as there are more pedestrians crossing at marked crosswalks than the other location types. The volume of pedestrians crossing at the different location types is difficult to quantify given the number of locations/intersections within the City.

The Party at Fault chart shows vehicles are found at fault around 80% of the time. This year shows the highest percentage with 83% of the collisions having the driver at fault. This is the highest percentage of drivers found at fault since we started tracking this number in 2014.

The Pedestrian Age chart shows the age distribution. The highest category is under 18, with 31% of the collisions (11 of the 35 collisions). This data does not necessarily suggest that pedestrians under the age of 18 are more likely to be involved in a collision, as we don't collect the total number of pedestrians walking by age.

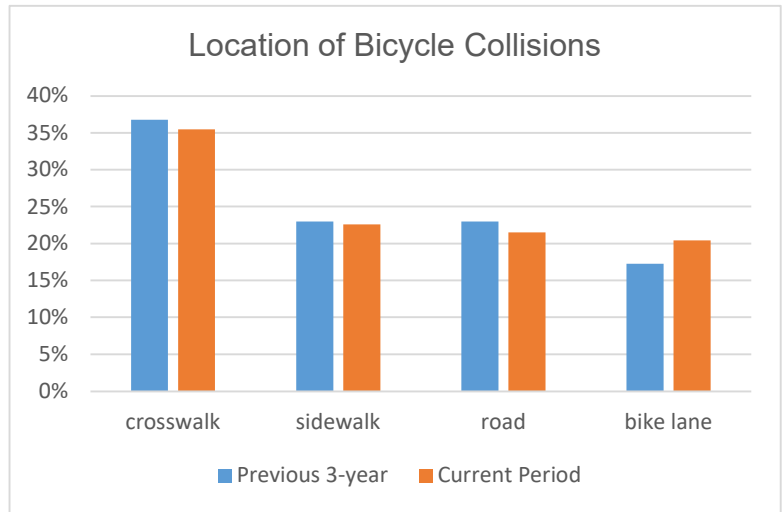
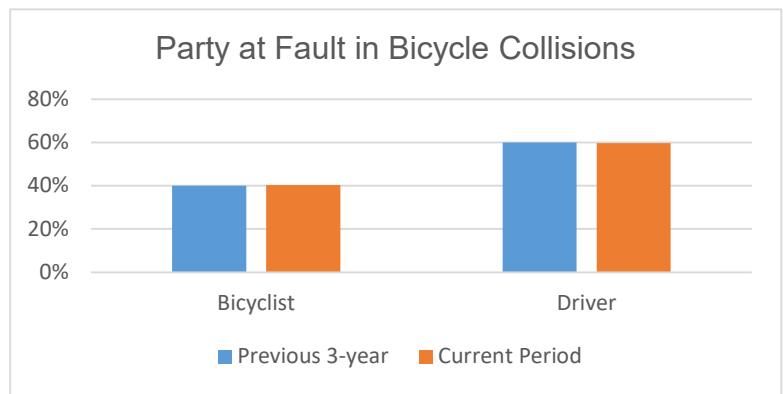
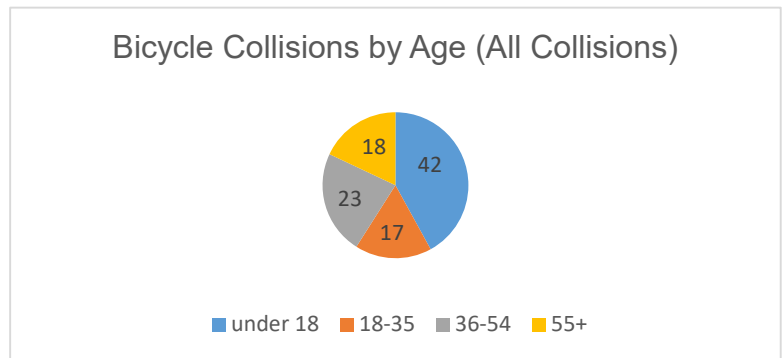
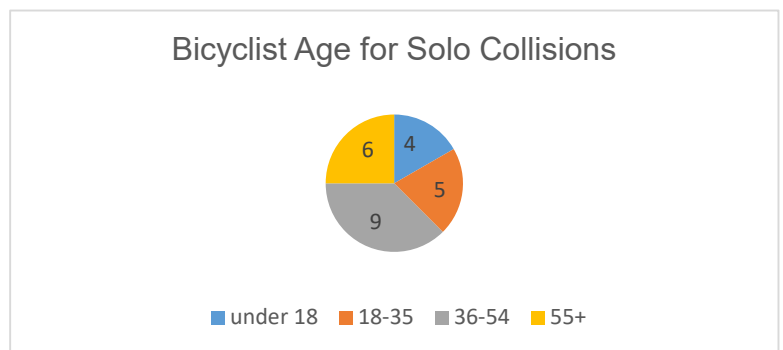
Similar to the pedestrian collision section, the location, fault and age statistics are shown to better understand who, where, and when bicycle collisions occur. The percentages of bike collisions that occurred in a crosswalk, on a sidewalk, in a bike lane, or simply on the “road” (outside of a bike lane or crosswalk) are shown on the bar graph to the right. Similar to pedestrian collisions, the greater number of collisions within a crosswalk does not necessarily indicate reduced safety.

Party at fault (bicyclist, driver or unknown) is shown on the bar graph to the right⁸. Bicyclists were found at fault in 40% of the collisions (excluding the solo bicycle collisions).

The Bicyclist Age chart shows the differences between age categories. The under 18 category has the largest share of bicycle collisions, 42% (42 of the 100)⁹. However, this does not mean that bicyclists under 18 are more likely to be involved in a collision as we do not collect the total number of bicyclists by age. Last period we also had 42% for the under 18 category. We are still below the historic average of 47% for this category.

The 55+ age group included 18 crashes with 33% of those solo. This is similar to the 36 – 54 age group where 39% were solo. This data doesn’t necessarily imply that older cyclists fall more often. It could be they fall at the same rate but are hurt more often.

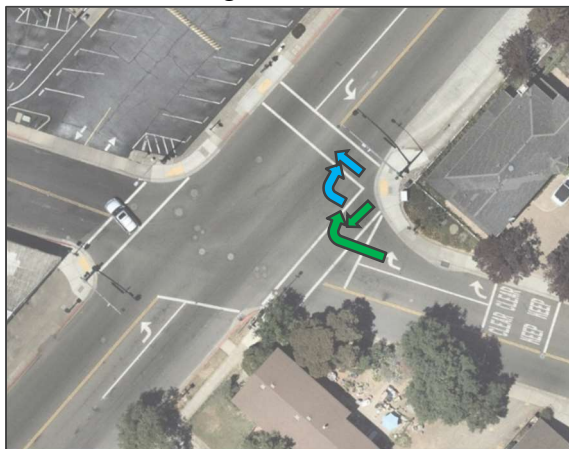
First Street at Spring Street/Kottinger Drive

Both collisions involved a westbound right turning vehicle hitting a pedestrian in a crosswalk (one in the east crosswalk and one in the north crosswalk). One of the collisions was a right turn on red and the other was a right turn on green. Right turning vehicles have good sight distance of this crosswalk, as long as they are looking in that direction.

Both of these collisions were reviewed last year, with no new collisions at this intersection. We conducted a 10-year collision review to determine if LPI (leading pedestrian interval) or prohibiting the right turn on red were needed. Countermeasures S21-PB and PLS-RTOR. Our analysis showed no collision pattern to support LPI or prohibiting the right turn on red.

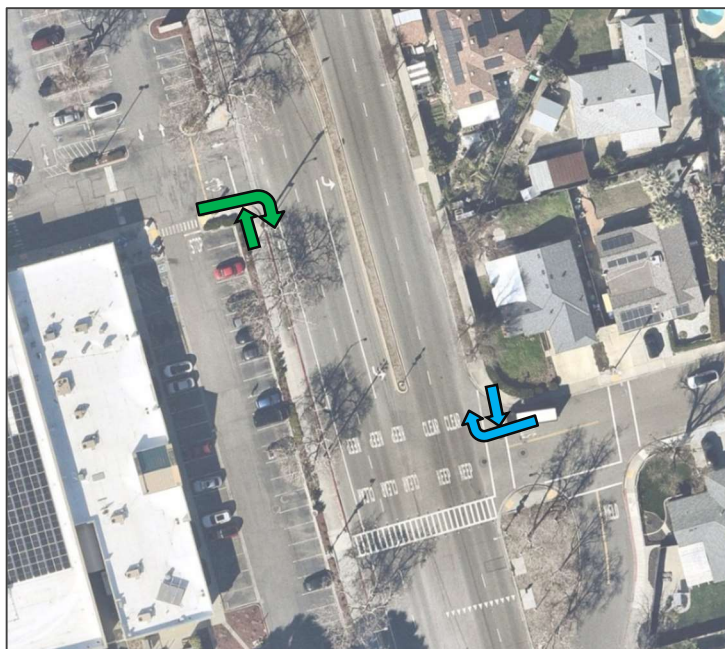
Santa Rita Road at Francisco Street

Neither of the two collisions occurred in the crosswalk across Santa Rita Road, and only one of the two collisions occurred at the intersection. The collision at the intersection was between a westbound right turning vehicle and a southbound pedestrian in the east crosswalk. The other collision occurred north of the intersection at one of the nearby shopping center driveways. Both collisions involved a right turning vehicle. No other patterns were identified and no actions recommended at this time.

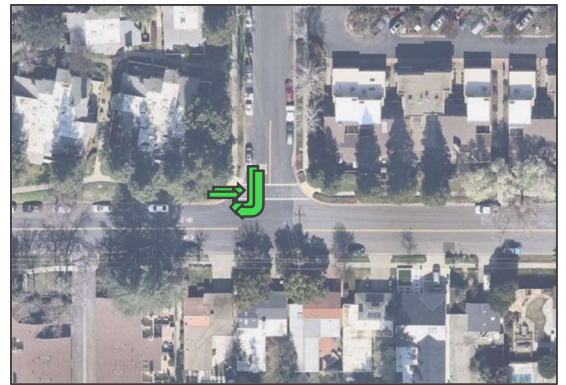
Black Avenue at Crestline Road

Both bicycle collisions involved a juvenile bicyclist being hit by a southbound right turning vehicle where the driver did not see the bicyclist. In both instances the bicyclist did not make eye-contact with driver before starting into the crosswalk.

Parking was removed to increase sight distance in August of 2024 and no further collisions have occurred at this intersection.

Caltrans countermeasure NS11. Staff also reached out to school district to promote bicycle safety to their students. Link to BikePleasanton.com was shared with information and current events/classes. Pleasanton countermeasure PLS-EDMSG.

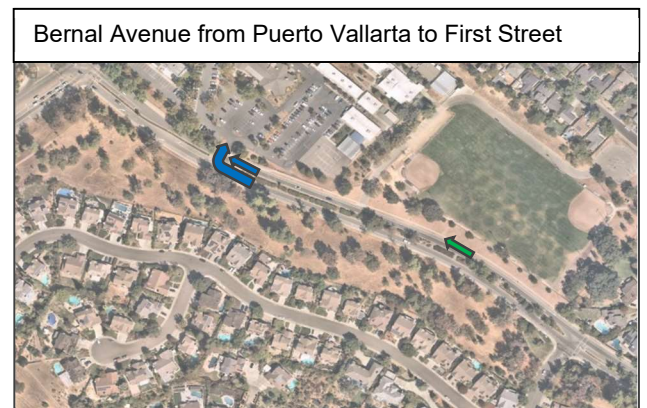
Two midblock segments were identified with more than one bicycle collision during the three-year period (Bernal Avenue from Puerto Vallarta to First Street and Santa Rita Road from West Las Positas Boulevard to Pickens Lane/Old Santa Rita Road).

The segment of Santa Rita Road also had two collisions. Both collisions happened in the Stanford/Valley Care driveway crosswalk and involved a northbound bicyclist being hit by an eastbound right-turning vehicle exiting the driveway to enter Santa Rita Road. In both cases the driver was looking left for gap in southbound traffic.

Install warning signage for northbound bicyclists/pedestrians to be cautious/make eye-contact with driver before crossing driveway. Caltrans countermeasure NS06.
