SUBJECT: ANNUAL BICYCLE AND PEDESTRIAN COLLISION DATA

Annual Collision Analysis 2024

This report summarizes the collisions within the City in 2023 and analyzes trends and patterns to identify changes that can be made to reduce the number of collisions. Reported traffic collisions involving vehicles, bicyclists and pedestrians are reviewed on a weekly basis by Traffic Engineering. The weekly review looks at individual collisions to determine if improvements can be made to improve safety. This annual report takes a comprehensive look at the one-year and three-year trends to identify larger patterns and improvements that can improve safety.

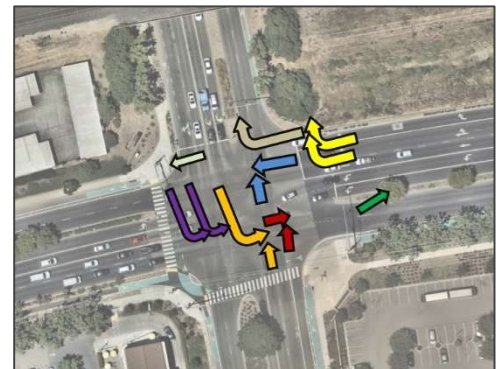
Stanley Boulevard at Valley Avenue/Bernal Avenue

Three of the eight collisions were hit object, all different objects, and all for different reasons (speed, weather, DUI). Three collisions involved a party running a red light (one westbound through and two northbound through). Investigation into the collision details determined a correctable pattern did not exist

No further patterns were identified and no changes are recommended at this time.

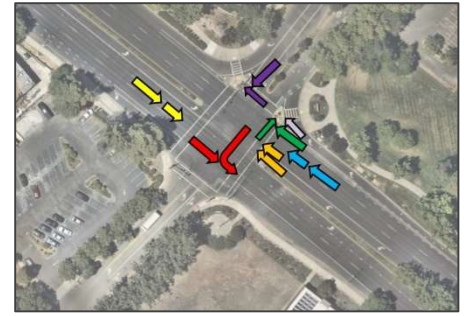
Hopyard Road at Parkside Drive

Three of the seven collisions involved a bicyclist (two in crosswalks and one in the roadway). These three collisions are looked at in greater detail in the bicycle section of this report.

No further patterns were identified.

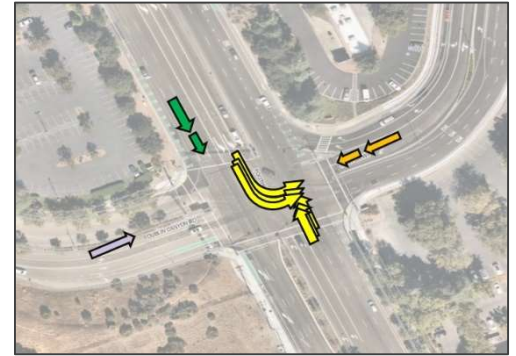
Foothill Road at Dublin Canyon Road / Canyon Way

Last year's analysis showed five of the ten collisions were broadside collisions caused by red-light violations (four northbound red-light violations and one southbound left turn red-light violation). All five of the red-light violation crashes involved the northbound through and the southbound left turn. Staff evaluated the visibility of the northbound traffic signal head and while adequate, an additional signal head was installed (Countermeasure S02). Two broadside collisions have occurred after the signal head installation. However, in both of those collisions the southbound left turning vehicle ran the red light.

No further patterns were identified, and no changes are recommended to this intersection at this time.

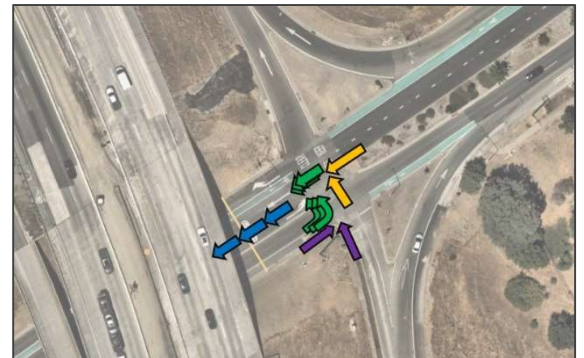
Sunol Boulevard at I-680 northbound ramps

Five of the six collisions involved drivers trying to enter the northbound I-680 on ramp being involved in a collision with either eastbound or westbound Sunol Boulevard vehicles. The majority of collisions at this location occurred outside of the peak travel periods.

This pattern of broadside/head-on collisions has been noted through this corridor in the past and this intersection will be signalized as part of the Sunol Boulevard I-680 Interchange Modernization project (Caltrans countermeasure NS03).

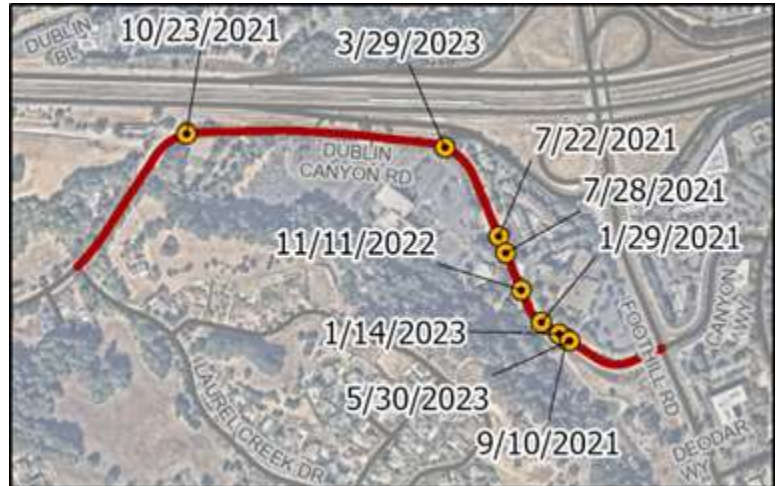
Dublin Canyon Road from Foothill Road to Laurel Creek Drive

We have identified this section of roadway in previous year's reports. In past years there was a pattern of collisions at the westernmost curve. Additional and larger signs were installed on this curve in 2016. Only one collision appears at that location on this report. Driver speed was 65-100 MPH, well above the posted 35 MPH speed limit and the posted 25 MPH curve advisory speed.

This year four of the seven collisions the vehicle left the roadway and struck an object (all different objects). When looking at the cause of those four collisions there were no patterns (DUI, fell asleep, excessive speed, swerving to avoid slowing vehicle).

Pavement striping was evaluated last year and found to be adequate. This roadway is due to be resurfaced later this year. We will look for opportunities to put in new striping to add extra notification of curves in roadway (Caltrans countermeasures R22).

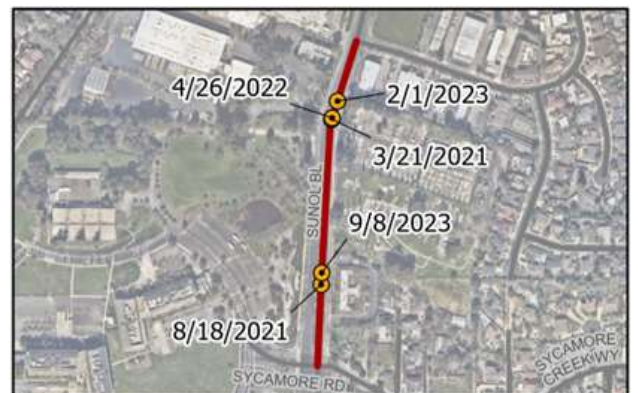
Sunol Boulevard from Sonoma Drive to Applied Biosystems/Sycamore Road

Two of the five collisions involved a southbound left turning vehicle into the cemetery. No other patterns were identified.

Evaluate sight distance of left turn pocket (Caltrans countermeasure NS11)

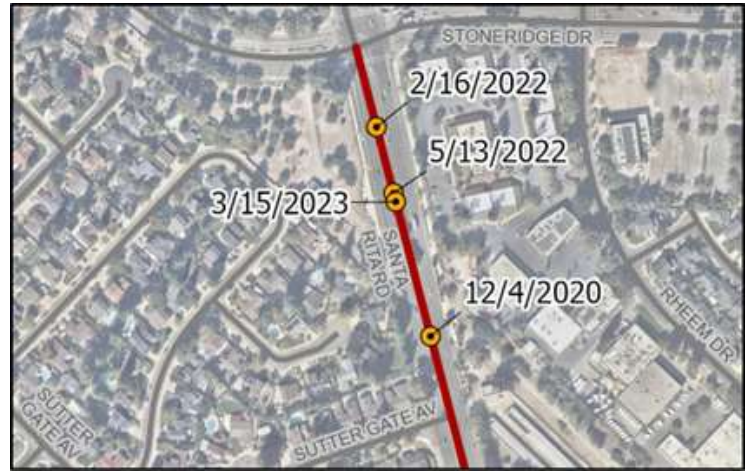
Santa Rita Road from Sutter Gate Avenue to Stoneridge Drive

Two of the four collisions were northbound rear-end collisions into stopped vehicles at the red light at Stoneridge Drive. Both of these collisions occurred midday on a weekday.

Evaluate midday traffic signal timing to see if more green time can be given to this direction (Caltrans countermeasures S03).

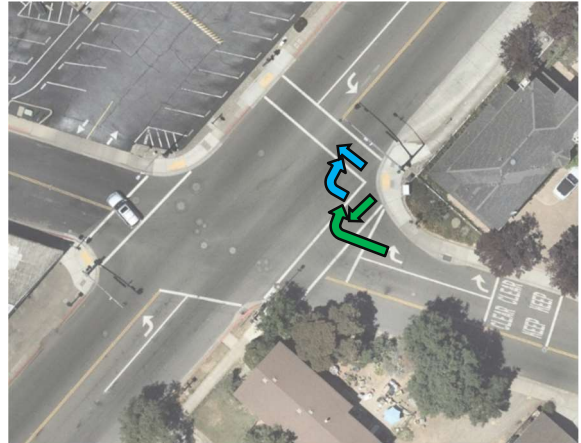
First Street at Spring Street/Kottinger Drive

Both collisions involved a westbound right turning vehicle hitting a pedestrian in a crosswalk (one in the east crosswalk and one in the north crosswalk). One of the collisions was a right turn on red and the other was a right turn on green. Right turning vehicles have good sight distance of this crosswalk, as long as they are looking in that direction.

Both of these collisions were reviewed last year, with no new collisions at this intersection. We will conduct a 10-year collision review to determine if LPI (leading pedestrian interval) or prohibiting the right turn on red are needed. Countermeasures S21-PB and PLS-RTOR.

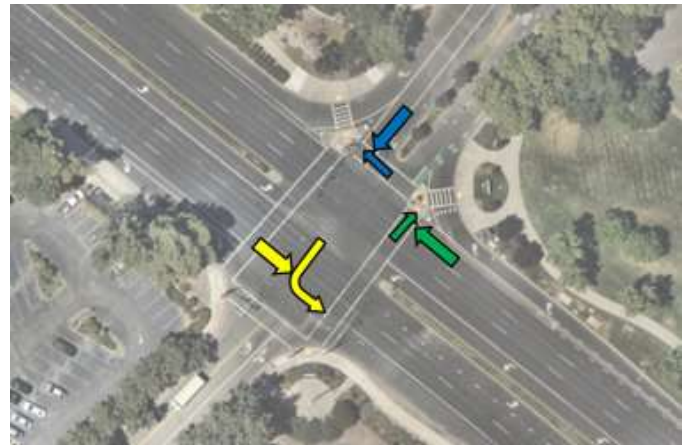
Hopyard Road at Parkside Drive/Valley Trails (south)

No further patterns were identified. Staff will upgrade detection to extend the all-red period (time the signal shows red to all directions between signal phases)

when a bicycle is detected in the intersection. Countermeasure PLS-BSMOD. Staff will also work with schools to get message to school aged bicyclists on the importance of using pedestrian push buttons at signalized intersections. Countermeasure PLS-EDMSG.

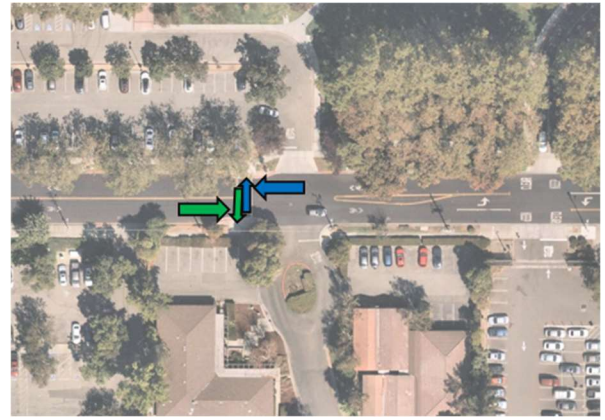
Black Avenue at Cedarwood Lane

Both collisions occurred in the same marked crosswalk, found the bicyclist at fault and involved a juvenile traveling to or from school. In the first collision the bicyclist thought the vehicle was slowing to let him cross. In the second collisions neither the bicyclist nor the driver saw each other prior to the collision.

It should be noted this crosswalk is bulbed out to increase visibility of those pedestrians/bicyclists choosing to cross there. This section of Black Avenue is level and straight with parking prohibited near the intersection to allow for good visibility. Pedestrian crossing signs are located both in advance of the intersection and at the intersection to identify this as a crossing location.

Both collisions were in 2022 and an RRFB was added to this locations as a countermeasure. (Caltrans countermeasure R37PB)

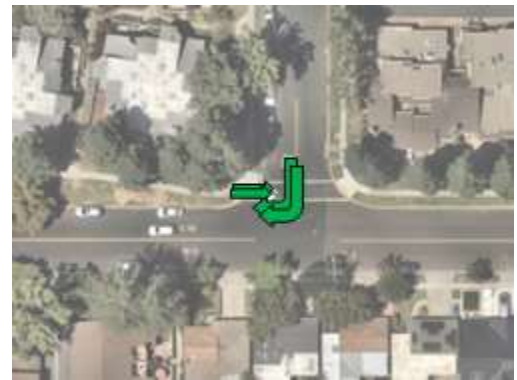
Black Avenue at Crestline Road

Both bicycle collisions involved a juvenile bicyclist being hit by a southbound right turning vehicle where the driver did not see the bicyclist. In both instances the bicyclist did not make eye-contact with driver before starting into the crosswalk.

Action to take: Work with the adjacent school on opportunities for students to be offered bicycle safety education (Countermeasure PLS-EDMSG). Remove parking on Crestline Road as you approach the intersection to increase sight distance. Countermeasure NS11

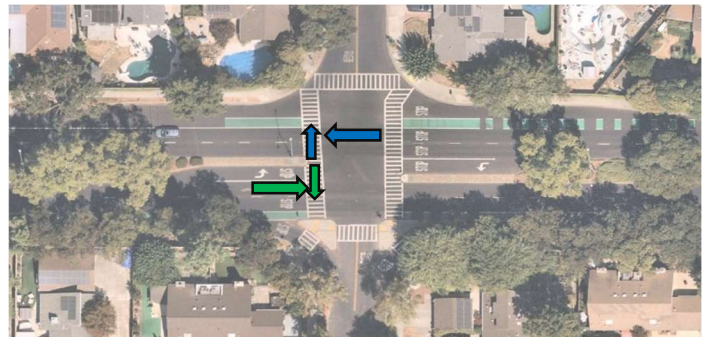
Valley Avenue at Blackbird Drive

Both of these collisions were on the last report. Both collisions occurred in the west crosswalk during the evening commute time period.

Action to take: We previously recommend considering a project to improve pedestrian visibility and reduce pedestrian exposure by eliminating right turn lanes and extending corners of the intersection. Countermeasure PLS-INTNAR. We plan to evaluate this intersection in the upcoming Safe System Approach project.
